位置資料							除甲醛前					除甲醛後					實證相片		
空間編號	空間名稱	樓層	NH <sub>3</sub>	HCHO	TVOC	C <sub>6</sub> H <sub>6</sub>	氯氣		NH <sub>3</sub>	HCHO	TVOC	C <sub>6</sub> H <sub>6</sub>	氯氣	除甲醛前數值	除甲醛後數值	實證			
C-G-Pc1	入口大堂	地面層	0.00	0.00	0.23	0.02	127		0.00	0.03	0.37	0.02	151

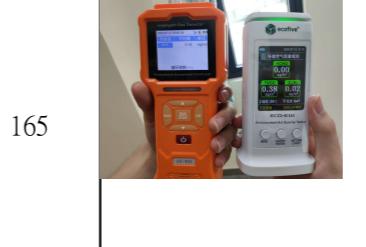
位置資料									除甲醛前					除甲醛後					實證相片		
空間編號	空間名稱	樓層	NH <sub>3</sub>	HCHO	TVOC	C <sub>6</sub> H <sub>6</sub>	氯氣		NH <sub>3</sub>	HCHO	TVOC	C <sub>6</sub> H <sub>6</sub>	氯氣	除甲醛前數值	除甲醛後數值	實證					
C-7-03	音響室	7	0.10	0.00	0.38	0.02	202		0.08	0.03	0.32	0.02	165

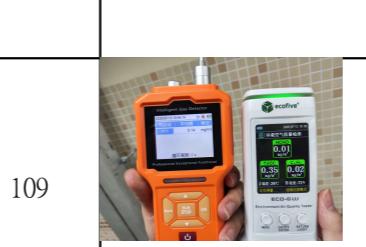
0.12	0.00	0.36	0.02	109
